XVII International Congress on Dry Stone

Larcena Daniele

AGRARIAN LANDSCAPES AND DRY STONE ON THE ISLAND OF BRAČIA

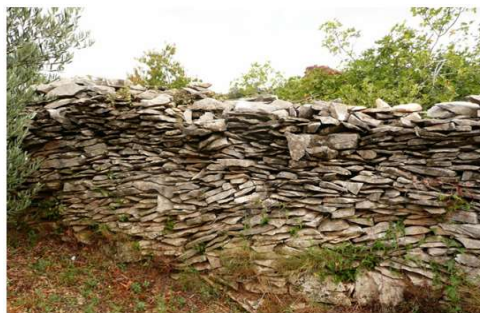
The construction of the walls (cogna) is very varied, it depends on the materials used but also on different practices. They are built with karstic materials from the Cretaceous secondary which provide either polygonal blocks of Urgonian facies, or slates of Barremian facies, or, in the villages, cut stones from numerous quarries.

Picture 5 *lauzes du secondaire crétacébarrémien*

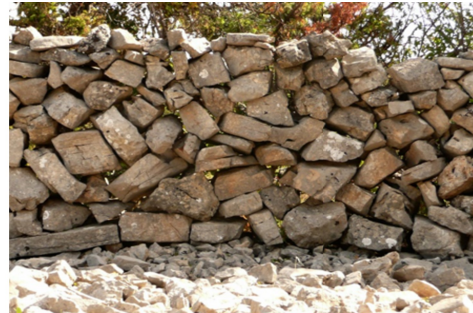
Picture 6 *mur ingula*

A particular type of wall is the lace wall (ingula), a wall that is not built but simply mounted in a rapid stack with empty spaces between the stones. These walls are found in livestock areas as a boundary for grazing, sometimes covered with thorns to prevent animals from jumping these fences. They are incised with semi-circular openings to allow the passage of animals without risk to the walls.

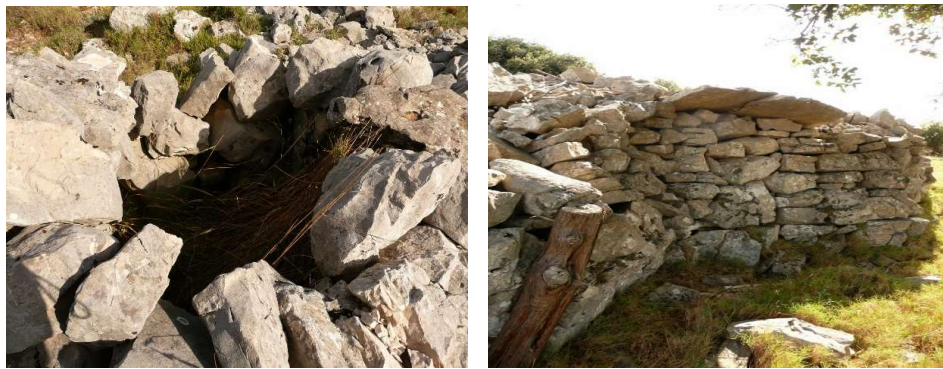
In the walls there are many small facilities for the use of the daily life of the peasants: the rabbit trap, the tiny shelter to tame a suckling ewe and an orphan lamb, the shelter against the wind, the larger shelter to allow the shepherd to make a fire and prepare his food, there are also flying stairs, stones with holes for the vines in espalier...

Picture 7 abri pour agneau

Picture 8 abri coupe-vent

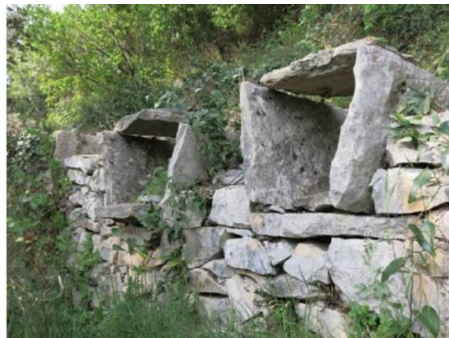
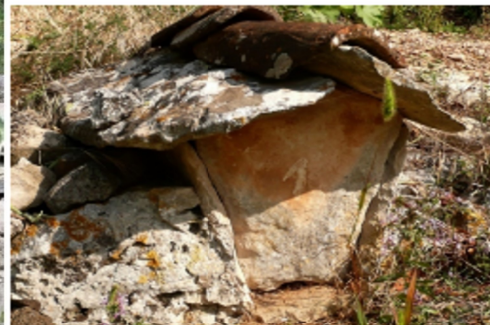
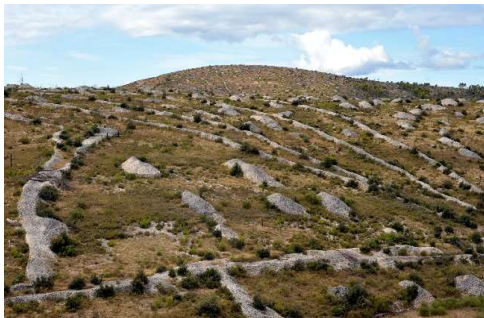
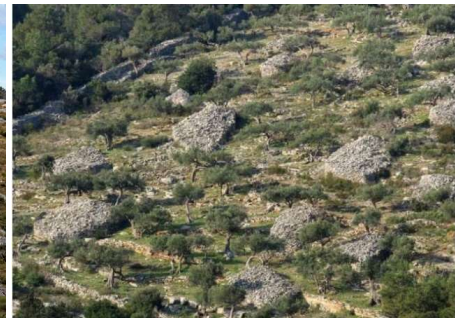
The most characteristic imprint of the landscape is undoubtedly that of the stone walls (gomila), whose total volume would represent that of the pyramids of Egypt! They are mounted and stored in circles, in ridges or in a fake little hut (a pile of tidy stones takes up less space than a pile of loose stones!). They represent an enormous stone work provided, over the centuries, by a large rural workforce. The development of these stony

soils, where stone work was necessary to clear some arable land, must in part date from the period of strong and rapid expansion of the vineyard when a large rural population was able, in a few years, to upset these slopes. It is not uncommon to see a slope with gomila-ridges, in the direction of the slope, as wide as the earth they free.

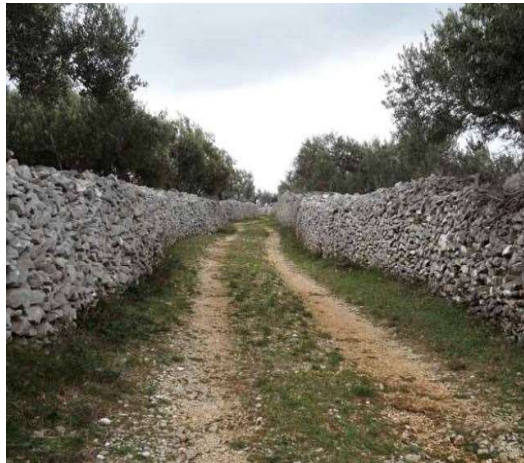
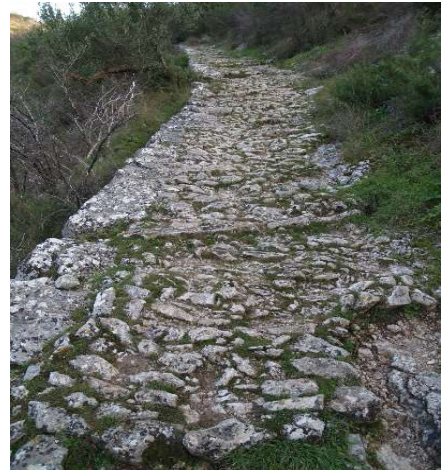
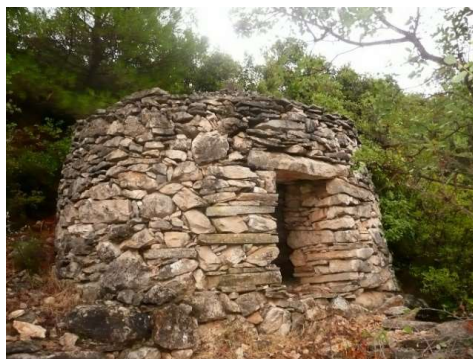
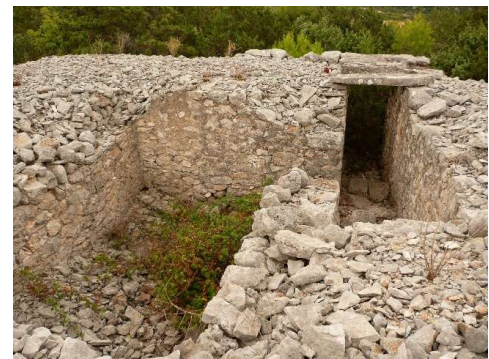
The lithic network of walls and paths is very dense (about 2,500 km on the island). It often corresponds to property boundaries (the thickness of a wall can be a sign of the owner's wealth). The paths are lined with double facing walls to protect the farmland, mainly along the large drailles where the herds pass. They can be stony and serve as ferries at the bottom of a valley. In the mountains, they are ensured by retaining walls wedged by large stone slabs.

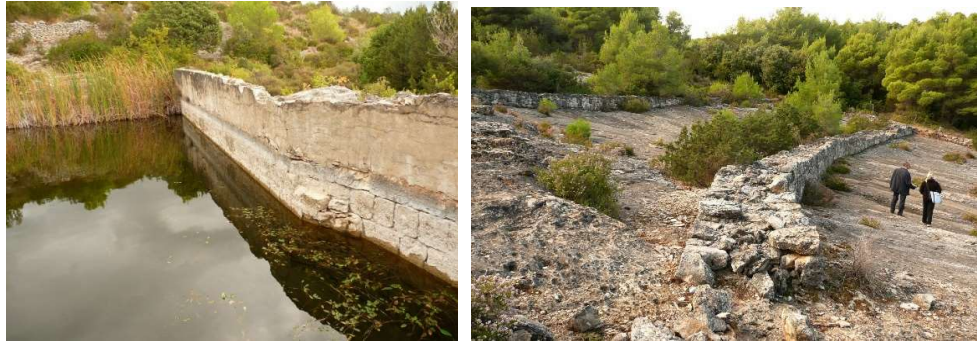
For example, in Krtine, a basin always in water was used in Sutivan in period of dryness at approximately 3km on foot.

An old botanical garden abandoned for 50 years near Supetar: it is laid out in 3 successive impluviums and 2 reservoirs-dams intended mainly for the inhabitants of Supetar and herds.

Picture 17 Krtine

Picture 18 jardin botanique

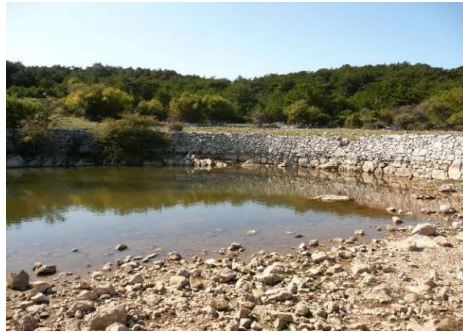
- Brakta water points: 2 waters of different origins, one seems rain-fed, the other coming from an aquifer; the edge of the lokva is stone wall supported to prevent the earth from spilling into the water.
- In Trolokve, south of Podgazul, there are 3 basins, collective property which served the whole island when the drought was raging. It is on these basins that the restoration work will take place in the spring of 2022.

Picture 19 lokva de Trolokve

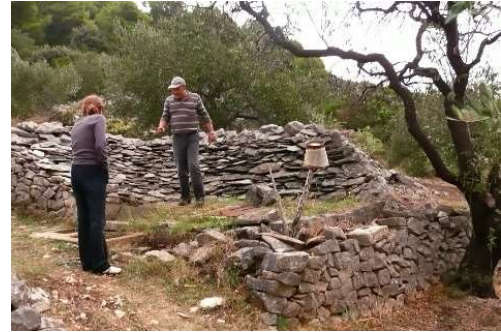
Picture 20 *jardin botanique*
